CHECK OUT INSPECTION

Check out inspection for:		Comments &
The property address		Findings

A check out inspection has been carried out referring to a copy of an inventory dated 00/00/0000 and apart from any stains, marks, etc. mentioned on the inventory the following observations were also made:

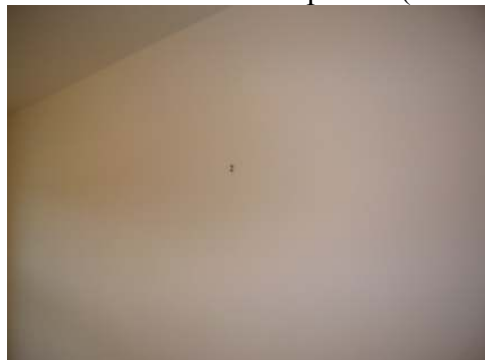
35. White emulsion on plaster (**TWO HOOKS**).

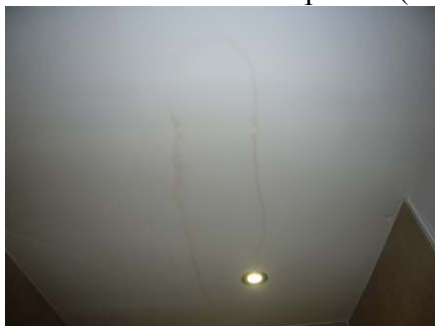
52. White emulsion on plaster (**WATER STAIN OVER SHOWER**).
